Intel® Celeron® Processor in the 478-Pin Package

Specification Update

April 2008

Revision 033

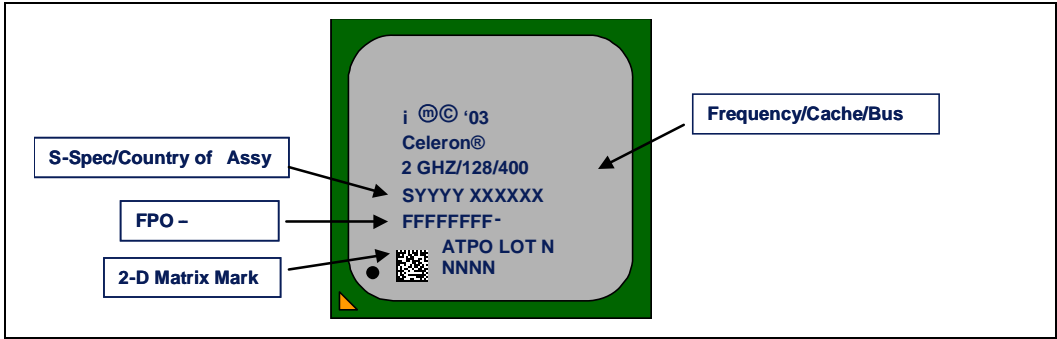
This section contains top marking information for the Intel® Celeron® processor in the 478-pin package:

Figure 1. Example Markings for the Intel® Celeron® Processor on 0.13 Micron Process and/or in the 478-Pin Package
